Review of Yerington Mine Characterization Activities

December 9, 2004

United State Department of the Interior
Bureau of Land Management
Nevada State Office

Technical Resources Group, Inc.
Idaho Falls, Idaho

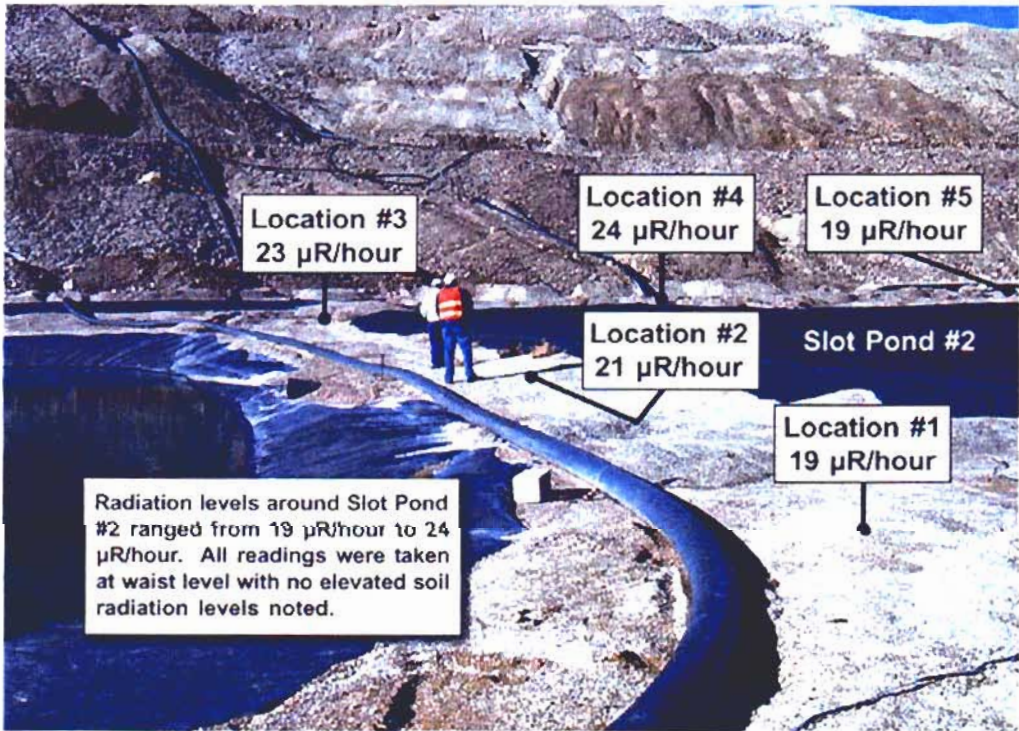
Results for radiation survey measurements performed around the Slot Pond 2 area are shown in **Figures 1-2**. As shown, these measurements did not identify radiation levels significantly above background levels for the area. The measured exposure rates ranged from 19 $\mu\text{R/h}$ to 24 $\mu\text{R/h}$ at locations 1-6 around the edge of Slot Pond 2. These measured levels appear to be consistent with measurements performed earlier by Foxfire Scientific, Inc. (Foxfire 2004).

Figure 1 Radiation Survey Measurements Results Performed Around Slot Pond #2.

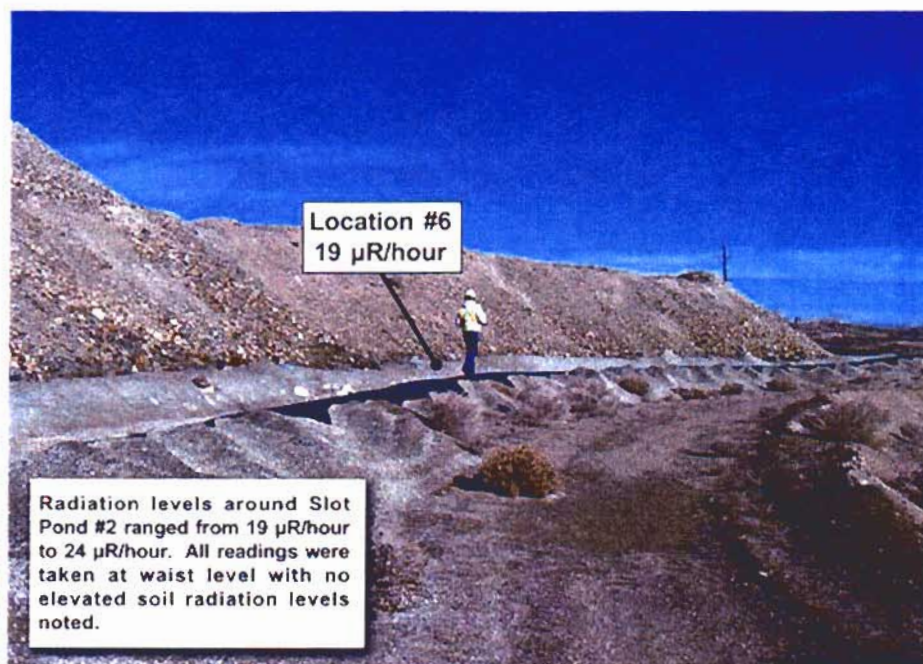
Figure 2 Survey Measurement Location 6 On North Side of Slot Pond #2.

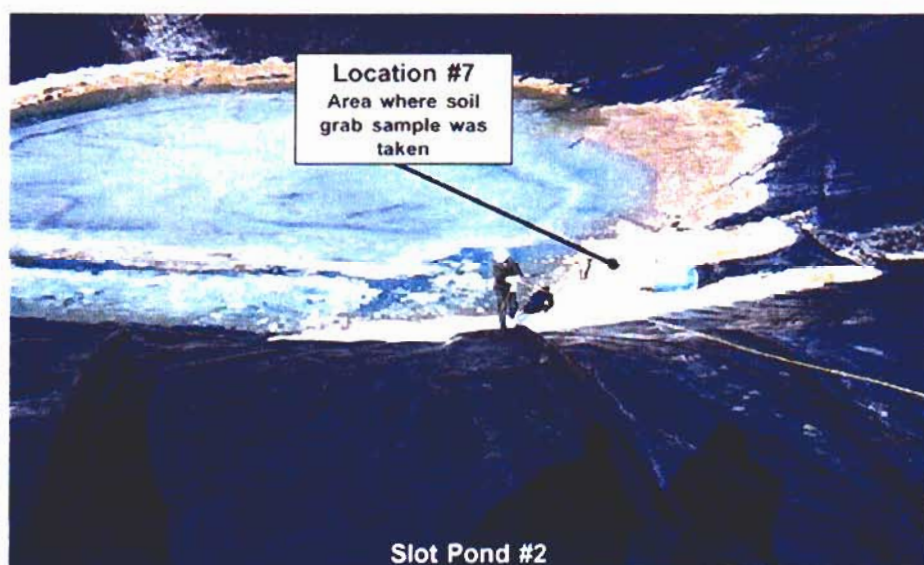
As shown in **Figure 3**, an employee of Brown and Caldwell collected the soil sample for the BLM while performing routine maintenance on a basin pump. The soil texture of the sample appeared to be a mixture of sandy-like soil and fine gravel. A radiation survey measurement performed on the soil sample did not indicate levels above area background.

Figure 3 Location of Grab Sample of Soil Collected from Basin of Slot Pond #2.

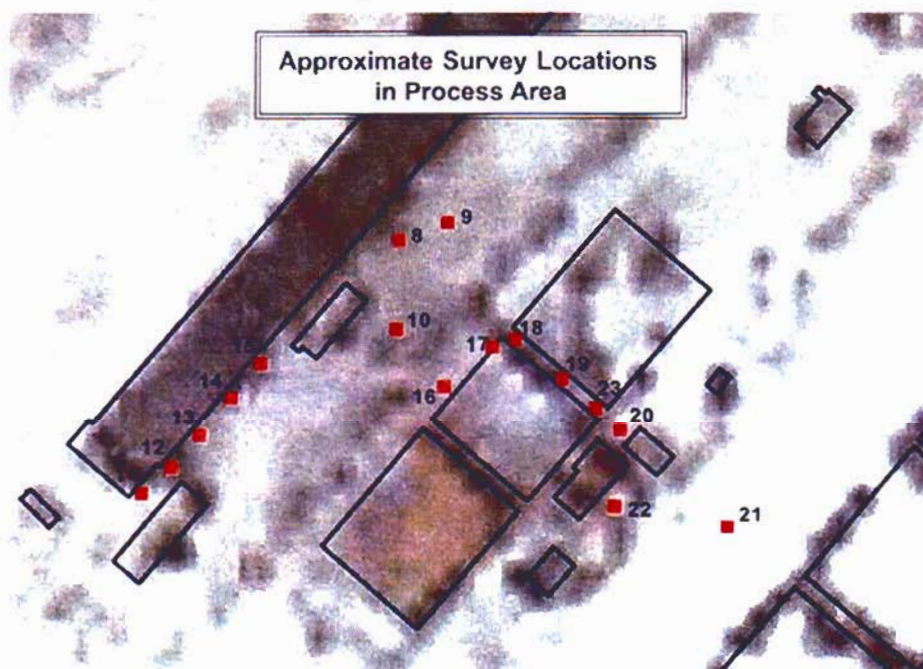
Survey locations for radiation measurements conducted around the process area during the BLM site visit are shown in **Figure 4**. The measurement locations, GPS coordinates, and radiation survey results for the process area are presented in **Table 2**. Surveys were performed around the iron launders, solution tanks, and one location near the upper vat tanks. A more detailed description for each of these areas is presented in **Figures 5-12**.

Figure 4 Radiation Survey Measurement Locations Around the Yerington Mine Process Area.

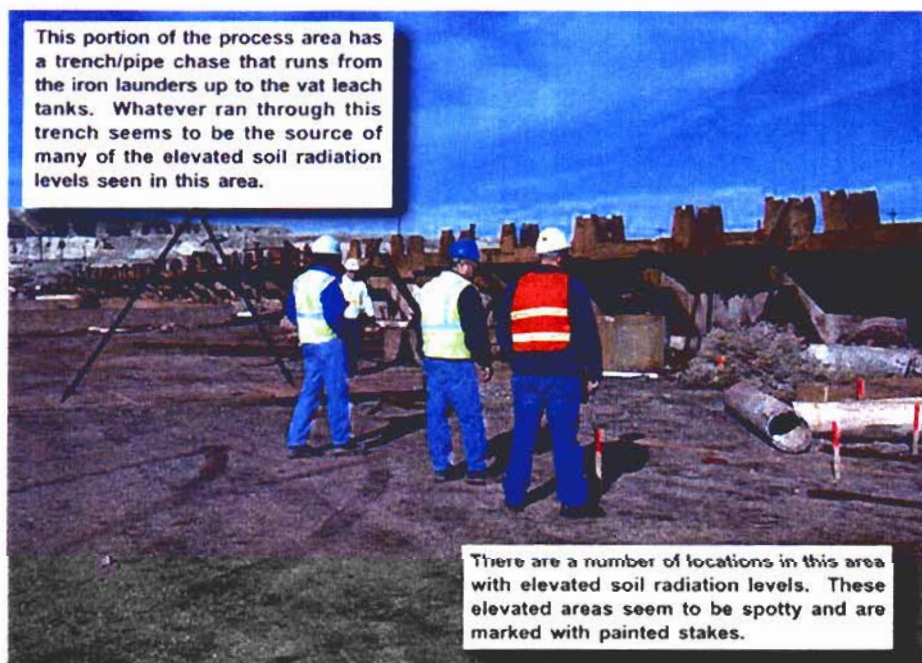
Radiation survey measurements conducted around the process area suggest that soil contamination (natural radioactivity, concentrated above normal background levels) has occurred over time from the copper extraction process. Survey locations 8-10 represent elevated radiation levels measured between the iron launders and solution tanks. As shown in **Figure 5**, there are several discrete soil locations that were previously identified and marked by the RCT as having elevated radiation levels.

Figure 5 Locations Previously Identified in the Process Area as Containing Elevated Radiation Levels.

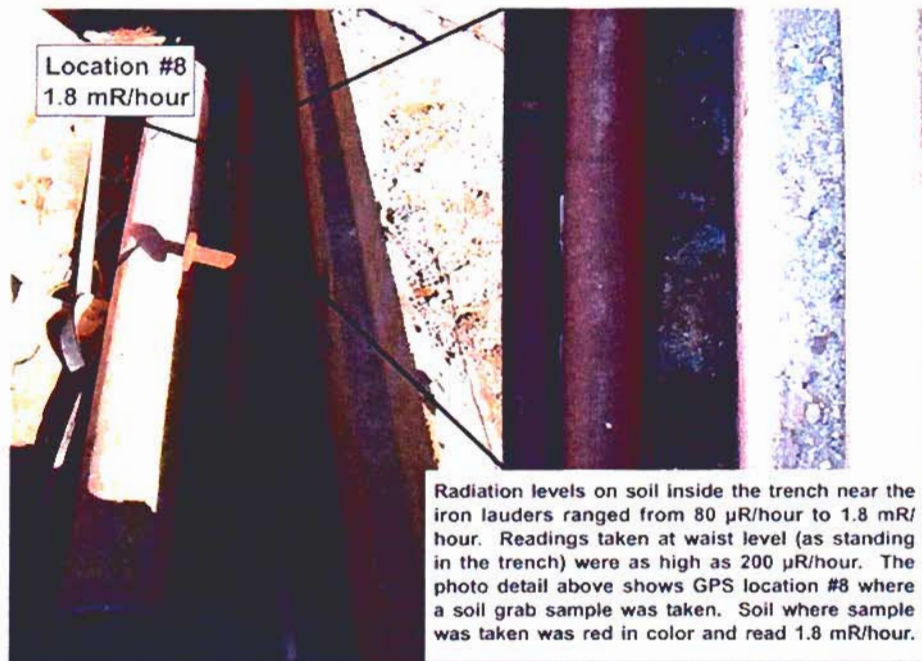
Soil contamination in these areas also suggests that subsurface piping, trenches and structures connecting the iron launders to the solution tanks may have contained elevated concentrations of natural radioactivity and most likely contributed to contamination observed in surrounding soils. Survey measurements obtained from location 8 were from a trench containing piping, which at one time may have been connected to the solution tanks.

As shown in **Figure 6**, radiation exposure rates ranged from 80 $\mu\text{R/h}$ to 1,800- $\mu\text{R/h}$ (1.8 mR/h) on contact with the soil in the trench. The general area radiation levels measured approximately 200 $\mu\text{R/h}$ at waist level. Based on the elevated radiation levels in the trench area, a grab sample of soil was collected from this location. The soil was red in color, similar to the soil and sludge seen in the solution tanks and the waste pond area.

Figure 6 Service Trench Located Between the Iron Launderers and the Solution Ponds.

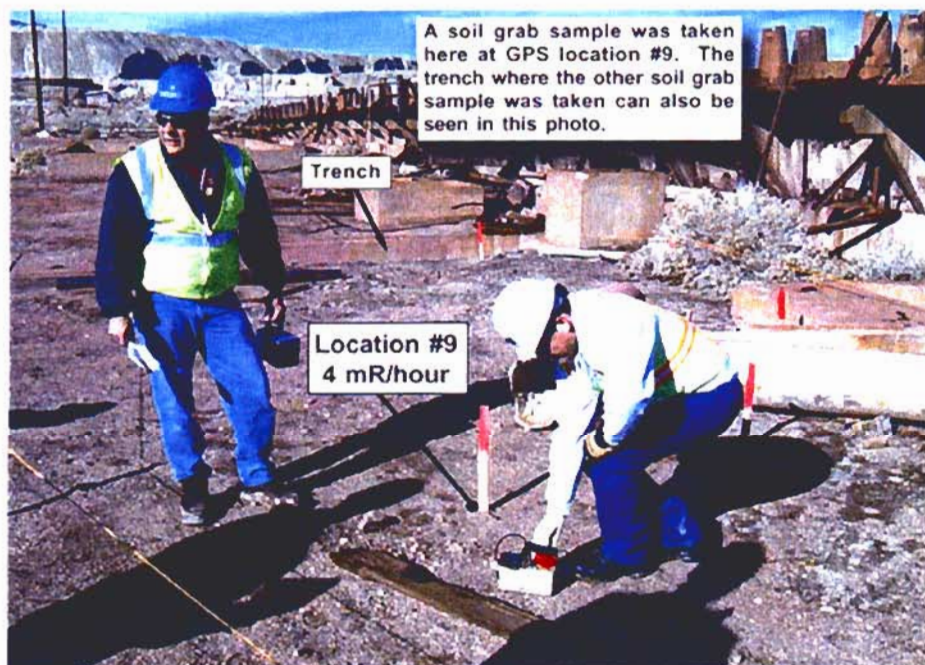
Figure 7 Measurement of Surface Soil with Elevated Radiation Level Near the Iron Launderers. Shown in the picture are the site RCT (in back) and a representative from TRG, Inc.

Survey measurements recorded for locations 9 and 10 are also near the iron launders. As shown in **Figure 7**, location 9 was previously flagged by the RCT and the immediate area was marked with a control barrier. The radiation exposure rates measured in this area were approximately 500 $\mu\text{R}/\text{h}$ at waist level, while reading 4,000 $\mu\text{R}/\text{h}$ (4 mR/h) on contact with the surface soil. A grab sample of surface soil was also collected from this location, near the post marker. Soil collected at this location was representative of other surface soils around the process area. There was no distinct discoloring to the soil like that collected in the trench area at location 8. A radiation survey measurement performed on the soil sample taken from this location yielded 2,000 $\mu\text{R}/\text{h}$ (2 mR/h)

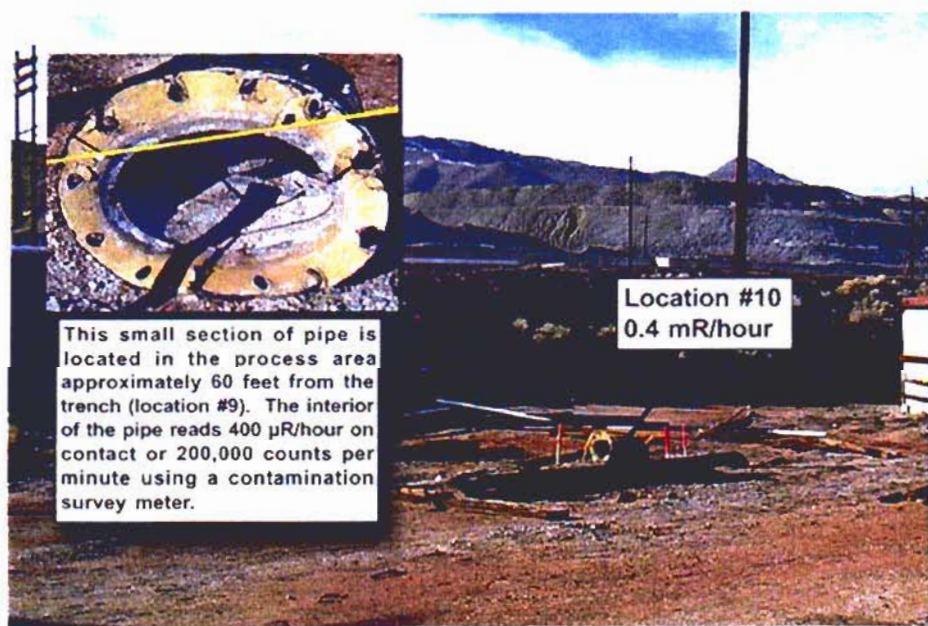
Surveys were performed on a small section of pipe located in the process area, between the iron launder and the solution ponds. As shown in **Figure 8**, elevated radiation levels were identified as pipe scale on the interior surface of the piping. The pipe scale containing the concentrated radioactivity was primarily fixed contamination (not readily removable from the surface). The contamination count rate was recorded as 200,000 counts per minute (cpm) on contact with the surface and recorded as location 10.

Radiation survey measurements from locations 8 through 10 suggest that elevated concentrations of natural radioactivity are likely to be located in subsurface trenches and structures, surface soil areas, and piping. Preliminary surveys conducted during this site visit did not identify unacceptable radiation levels to personnel performing characterization work in the general area. However, there are discrete soil areas, and trenches in the process area that should be characterized and posted to minimize direct and prolonged contact by workers.

Figure 8 Survey Location 10, Small Section of Pipe Containing Fixed Contamination on the Interior Surface.

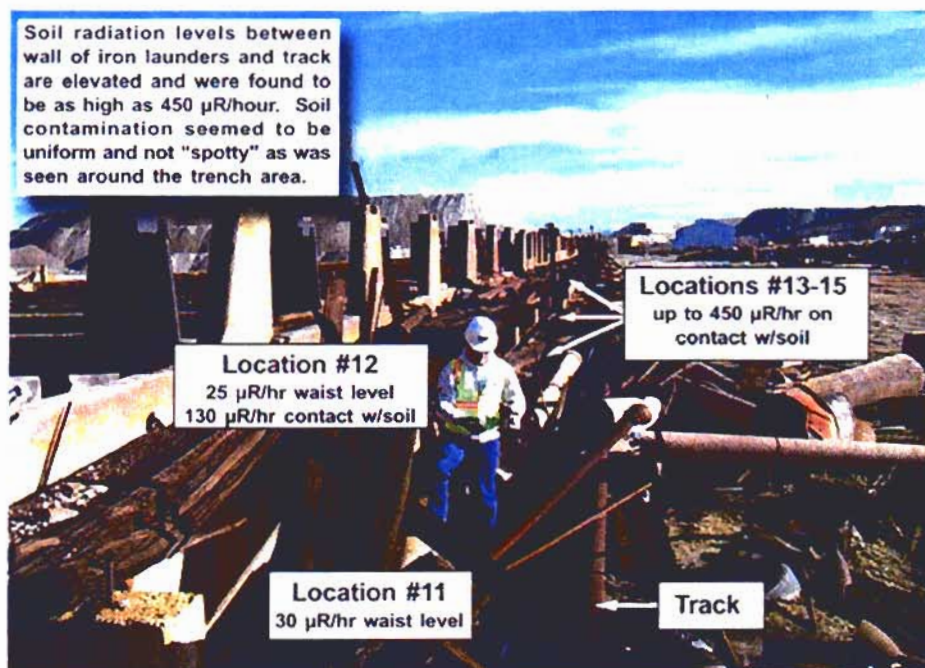
Survey locations 11-15 are located between the iron launders and rail track. The radiation exposure rates recorded in this area ranged from 25 $\mu\text{R}/\text{h}$ to 30 $\mu\text{R}/\text{h}$ level at waist level. The highest level recorded on contact with surface soil in this area was 450 $\mu\text{R}/\text{h}$. Radiation levels measured around this area were more uniform than previous measurements collected in the trench and surface soil areas. However, as shown in **Figure 9**, there is a large amount of structural and process debris that has weathered over time and now restricts access within this area for completing a thorough radiation survey.

Figure 9 Survey Locations 11-15 Adjacent to the Iron Launders and Rail Tracks.

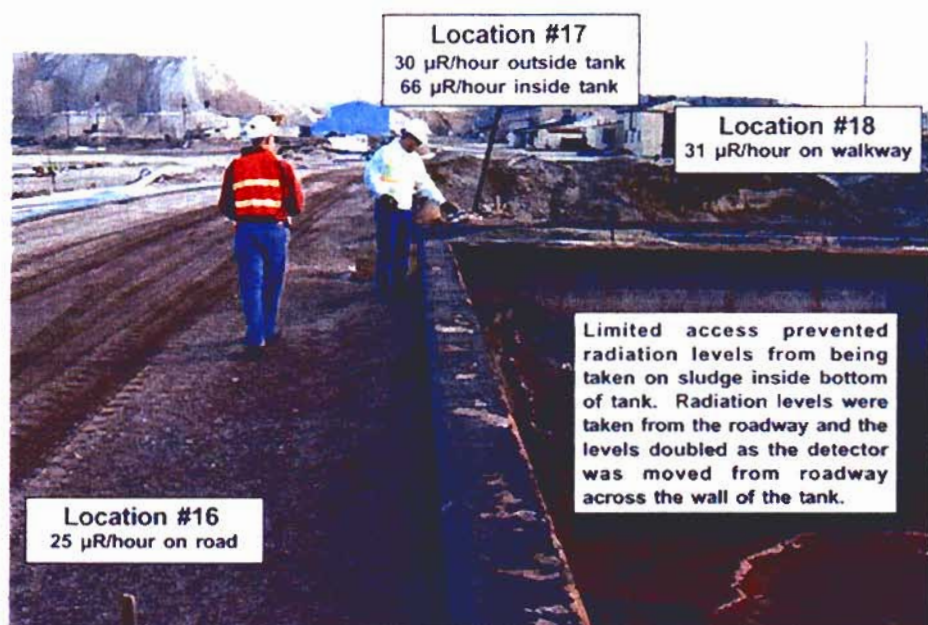
A final set of surveys was performed around the solution tanks and middle walkway, leading to the upper vat tank area. As shown in **Figure 10**, location 16 was a measurement taken on the roadway between the solution tanks and the iron launders. The radiation exposure rate increased as the detector was moved closer and then over the edge of the solution tanks.

Location 17 consisted of two measurements. The first measurement was taken on the outside portion of the solution tank wall near the ground surface, while the second measurement was taken on the inside portion of the wall, while extending the instrument down in the tank as far as the surveyor could reach. As shown in **Figure 10**, the residual sludge still remaining in the tank has a characteristic red color as identified for other locations in the process area where elevated radiation levels were observed.

Figure 10 Survey Locations 16-18 and Radiation Levels Recorded Around the Solution Tanks.

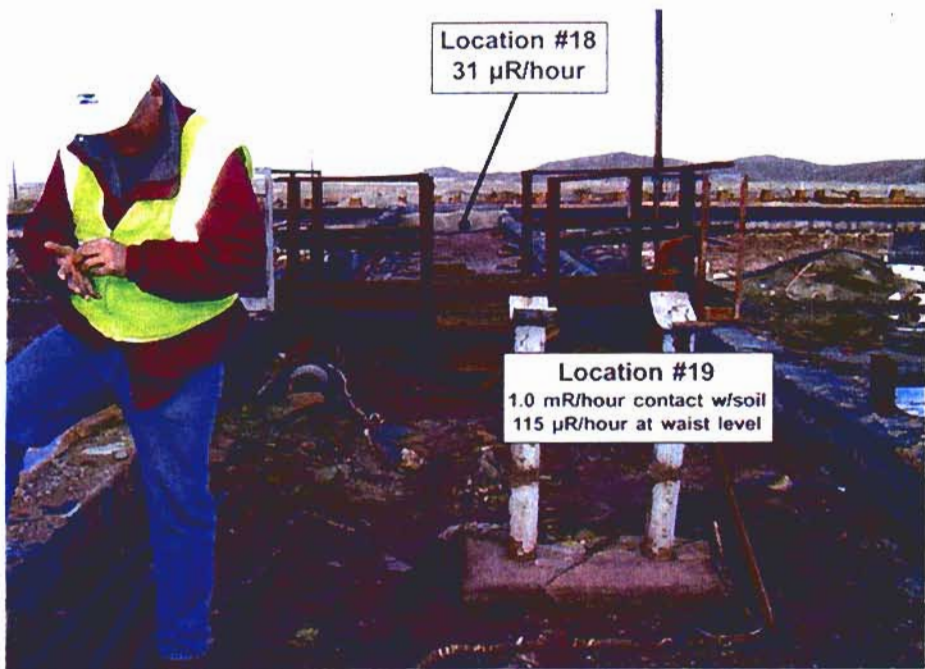
Measurement locations 19, 20, and 23 were located at the upper edge of the walkway between the solution tanks, near the wooden bridge and stairs. As shown in **Figures 11 and 12**, elevated radiation levels were identified in this area. The measured radiation exposure rate ranged from 40 $\mu\text{R}/\text{h}$ at waist level for location 23 to the highest surface measurement of 5,700 $\mu\text{R}/\text{h}$ (5.7 mR/h) on contact with the surface at location 20.

Figure 11 Measurement Locations 18 and 19 Located on Walkway Access Between the Solution Tanks.

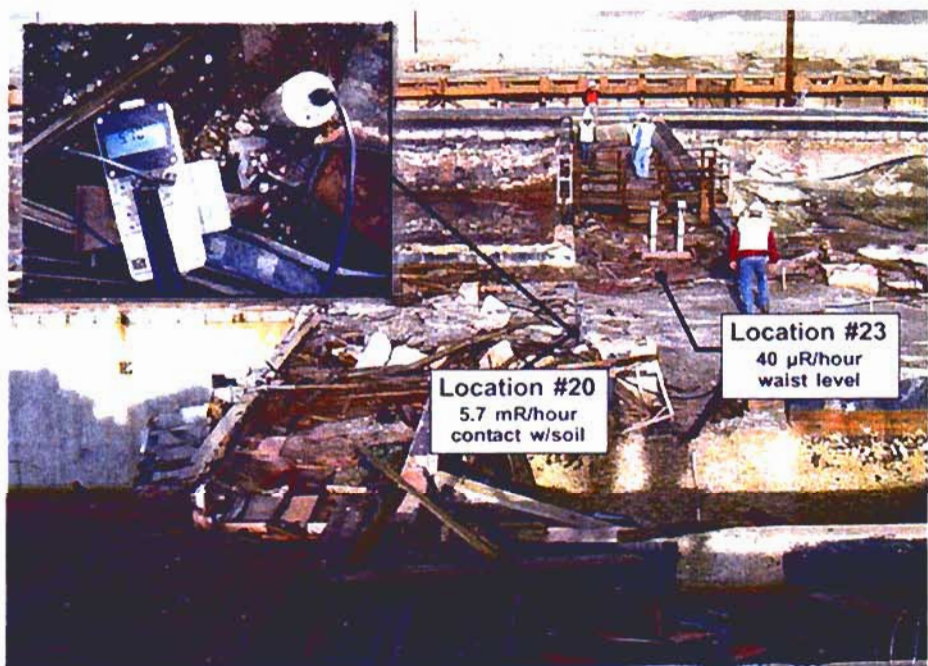
The source of elevated radiation in location 20 consisted of heavy wood timber that appeared to be contaminated with the red colored material. This red like soil has the appearance of the sludge material in the bottom of the solution tanks and some surface soil areas around the process area and waste ponds.

Figure 12 Measurement Locations 20 and 23 Located on Upper End of the Walkway Access Between the Solution Ponds. The Highest Measured Exposure Rate of 5,700 $\mu\text{R}/\text{h}$ (5.7 mR/h) was found on contact with debris and red-colored soil and is shown in the photo detail above.
